HOUSE DAMAGE ASSESSMENT

URS Research Company

June 1972

Summary Report
HOUSE DAMAGE ASSESSMENT

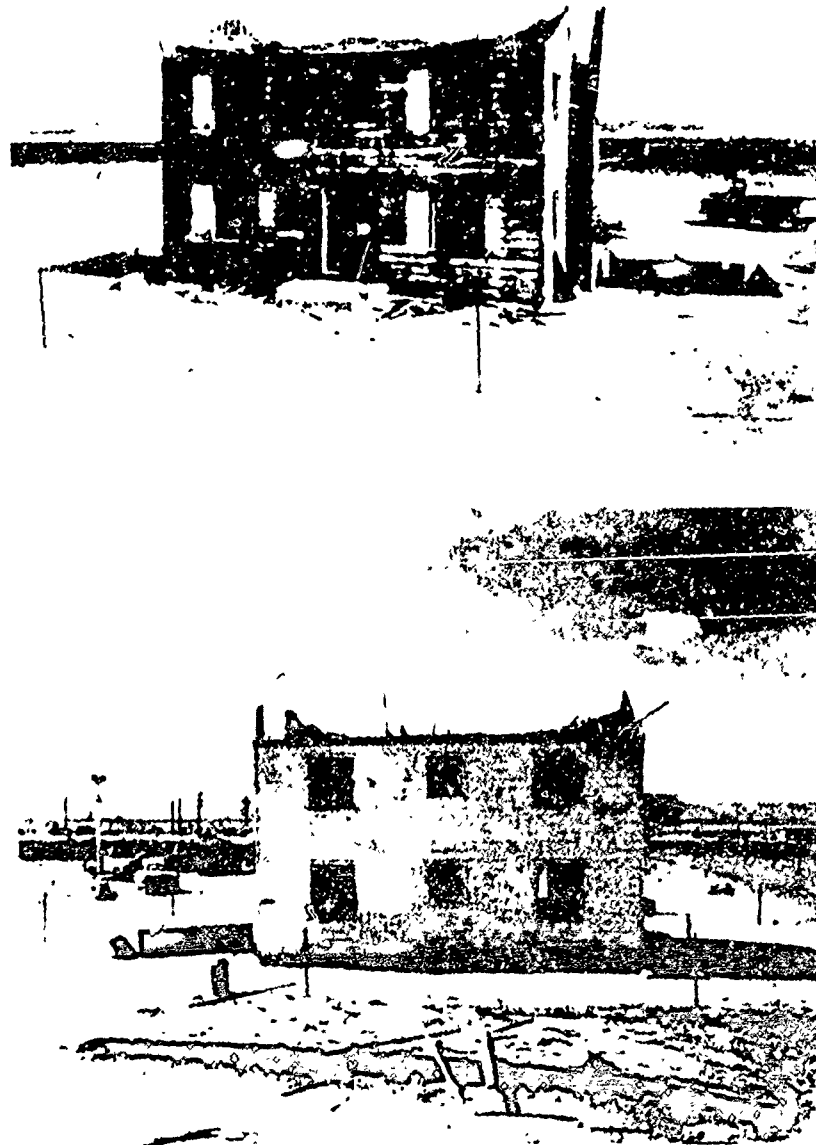
Fig. 2-22. Post-Shot Photos of House 1-3

This house was located 5500 ft from ground zero where the incident peak overpressure was approximately 4 psi. The superstructure of the house suffered severe damage, as can be seen in Fig. 2-22. The blast broke the rafters of the roof at midspan, and flattened the entire front section, with the sheathing and roofing attached, down against the ceiling joists. Most of the 2- by 10-in. rafters were split lengthwise. The rear half of the roof was lifted from the house and was dropped to the ground 25 ft to the rear of the house with the sheathing and most of the shingles attached.
